Quick Bally Driver Board Repair / Bulletproofing

The original guide was written by vid1900 and can be found at <https://pinside.com/pinball/forum/topic/vids-guide-quick-bally-driver-board-repair-bulletproofing>

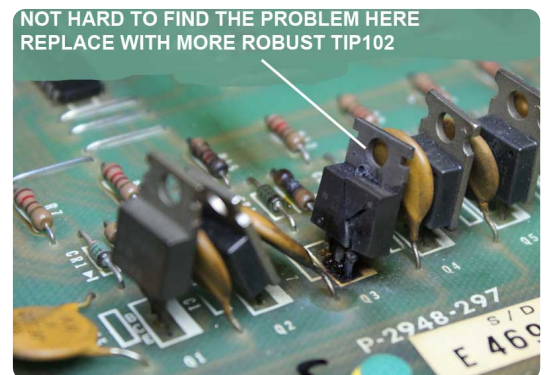
Supersonic is blowing fuses. I open the backbox and see Q3 damaged on the driver board.

Q3 is the knocker, I believed, so we lift the playfield to see what it looks like.

I cut the knocker out, before it can do any more damage.

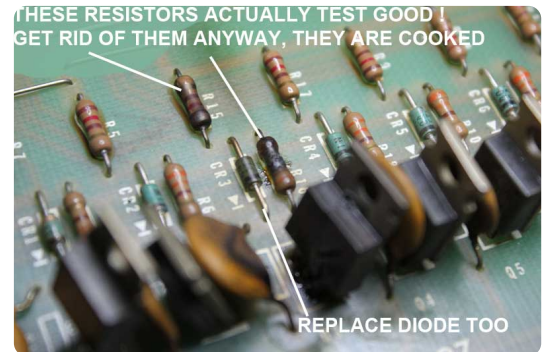
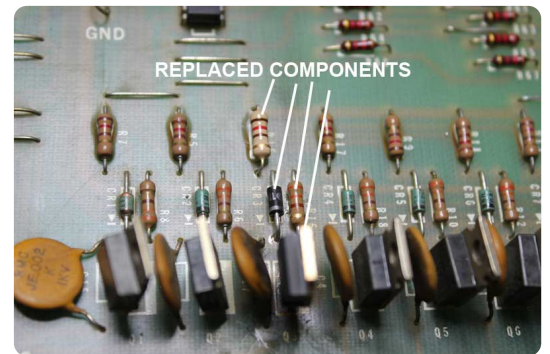
The associated 120 and 330 ohm resistors are nicely blackened, as is the 1N4004 diode.

Believe it or not these resistors still test good!

I pulled them and the diode out. Even though they work now, there is no sense in leaving a ticking time bomb.

The TIP102 transistors are much higher rated parts than the originals, always good to have on hand.

The diode has a band on it that has to be installed in the same direction as the original.

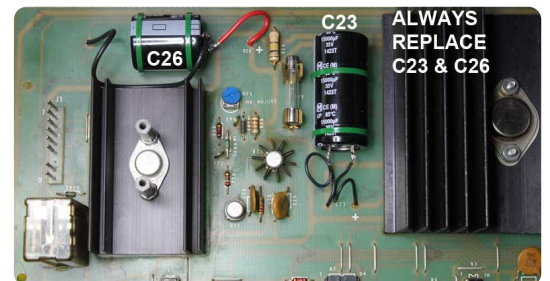
Job number one, ALWAYS replace the capacitors C26 and C23.

The new caps are always smaller in size, even though I always use higher voltage parts.

C23 was a 11,000uf 20v cap - I replaced it with a 15,000uf 35v unit.

C26 was a 150uf 350v cap - I replaced it with a 150uf 450v unit.

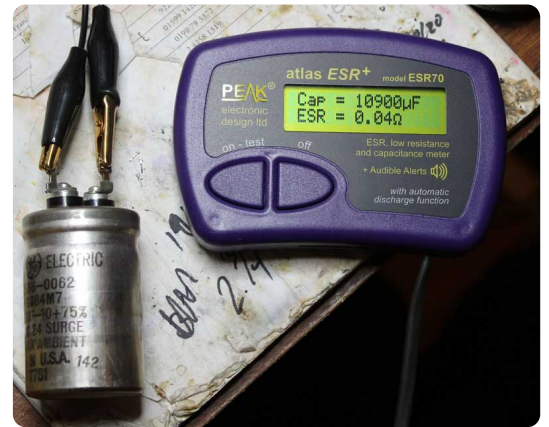
Lets look at the 11,000uf unit, C23.

It tests good as a capacitor & it looks good on the ESR meter.

For how long is anybody's guess, but right now it's good.

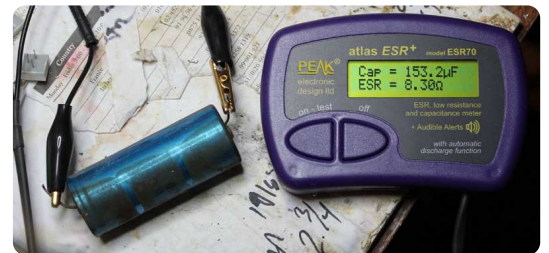
Now we look at the 150uf cap, C26.

The capacitance reading is good, but look at that high ESR reading!

Your normal VOM meter would have said this cap is good, but the ESR meter tells the whole story. This cap is on its way out.

For reference, the replacement cap had an ESR of .06 ohms.

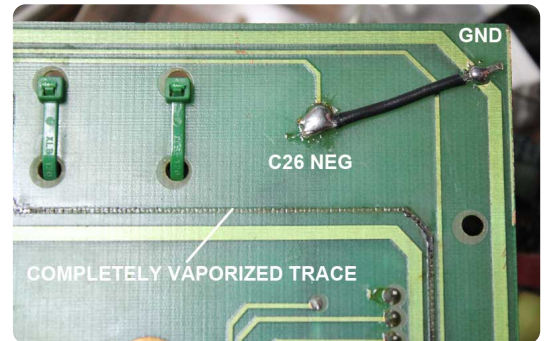
Next on the bulletproofing is to tie C26's NEG leg to ground.

Note also the completely vaporized board trace. I replaced that trace with a wire, hot glued to the board.

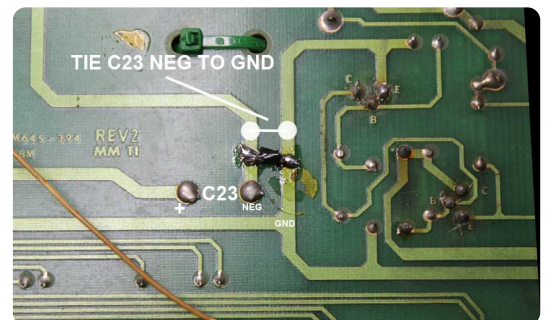
We also need to tie C23s NEG leg to ground.

Just scrape off some of the conformal coating and solder in your jumper.

Note the not too bad solder joints on the transistors that have been replaced in the past.

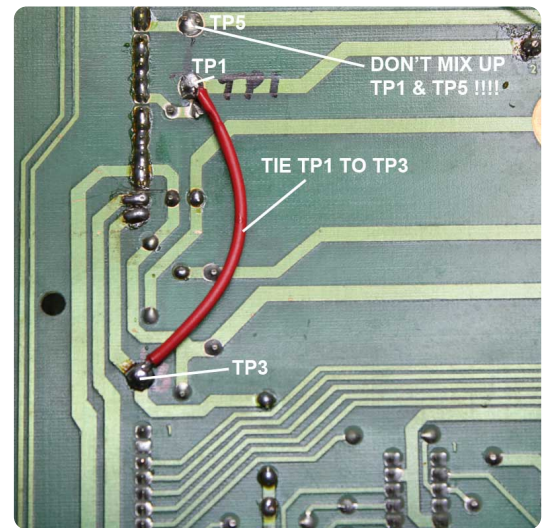
Next we always tie Test Point 1 to Test Point 3.

Otherwise the voltages take a crazy run off the board and back through the connectors.

Before you tie them together, you will see that they are often different voltages.

Don't mix up TP1 and TP5 or you will cause lots of damage!

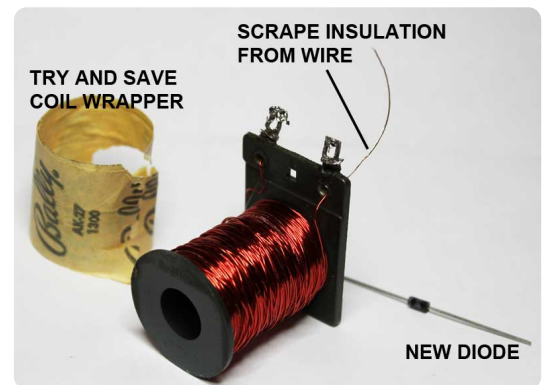
So back to the knocker coil. I sure did not have one with me, and the existing one did not have a diode on it - probably taken from the EM machine next to it.

The coil did not smell burnt.

It did have a puncture through the wrapper that had chipped off the red insulation.

I removed the wrapper and looked at the chip, it seemed that maybe the chip was shorting the coil (the coil resistance was something like 2 ohms).

After snipping the end of the wire off, I unwound the coil until I was passed the damaged part.

Then I scrapped off the insulation and wrapped the bare wire around the lug. I tested the resistance and we had a good coil again.

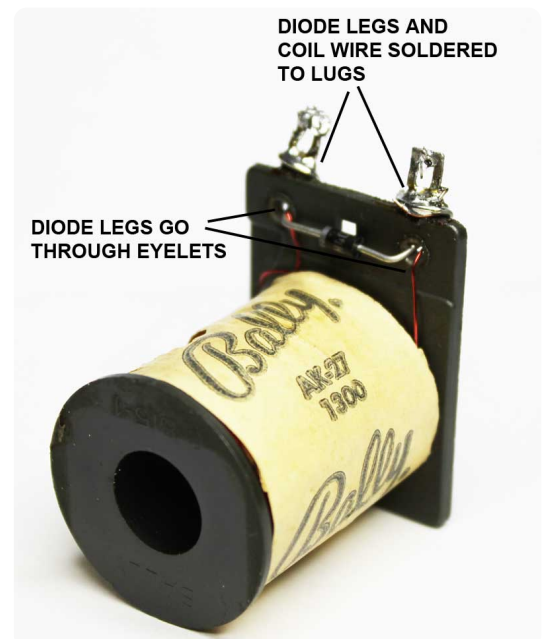
Next I stuck in a new diode and wrapped its legs around the lugs.

I soldered both lugs and the coil was ready for action again.

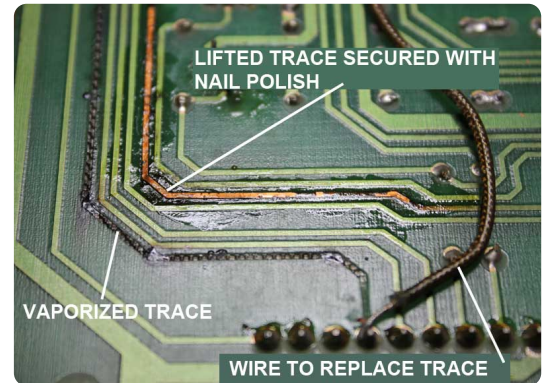
One of the traces from the Q3 transistor had lifted from the heat of too much current being run through it, but it still had continuity.

The other trace in the picture was not so lucky. It completely burned up.

I used clear nail polish to "glue" it back down to the circuit board. Nail polish dries very fast, so put some under the trace, wait about 20 seconds and then hold it down with the tip of a resistor lead.

Put some polish over the top also, to help insulate it.

I use a wire to replace it, and latter glued it down with hot glue.

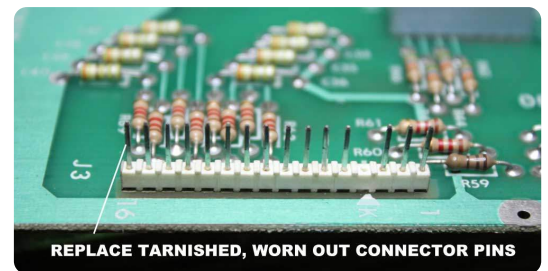
Job one: get rid of these old and tarnished connectors.

You can see that they have been sanded many times over the years to try and clean off the oxidation.

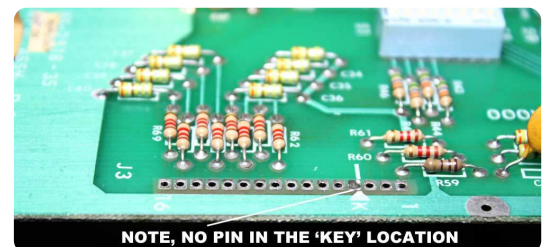
Since I'm on the road, I have to use my Hakko desoldering gun rather than my benchtop Metcal. The Hakko makes quick work of removing the old connectors.

Note that I leave the "key" position full of solder - you can't make a mistake that way and leave a pin in the new connector housing.

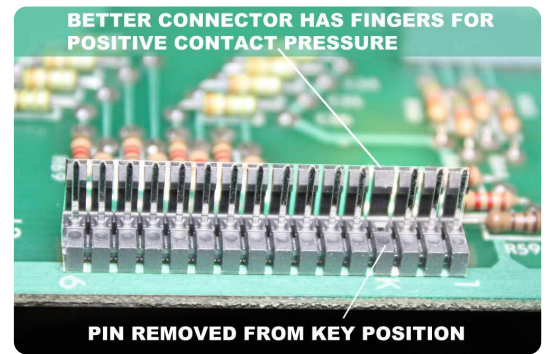
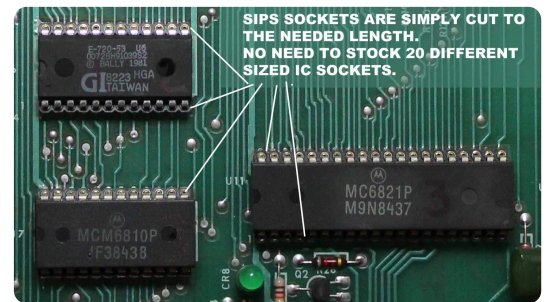
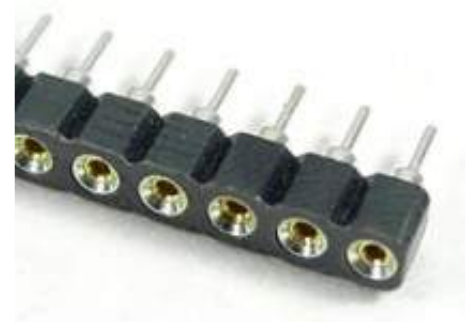
The old Bally connectors were about as crappy as you can get.

The new ones are much more robust and have a backing spring finger that puts positive pressure on the female part of the connector, locking it in place.

Some of them were so weak that I could pry up one end of the chip with my fingers (normally you need a flat screwdriver to remove a chip).

I pulled the Key pin out with a pair of needle nose pliers, and soldered the connector in.

Next, all the old IC sockets were removed.

I replaced all the sockets with SIP sockets. SIPs are cut to any length, so you don't have to keep a ton of different IC sockets in your inventory. SIPs have an amazingly strong grip on the chips, you are not going to pull any chips out by hand - that's for sure.

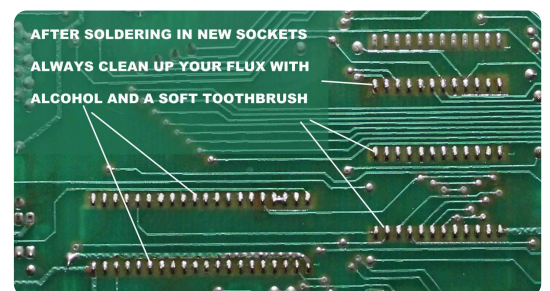
After soldering, make sure you clean up all the flux with Alcohol.

It is a sign of good workmanship, and it keeps the flux from further corroding the board, or high voltage arcing.

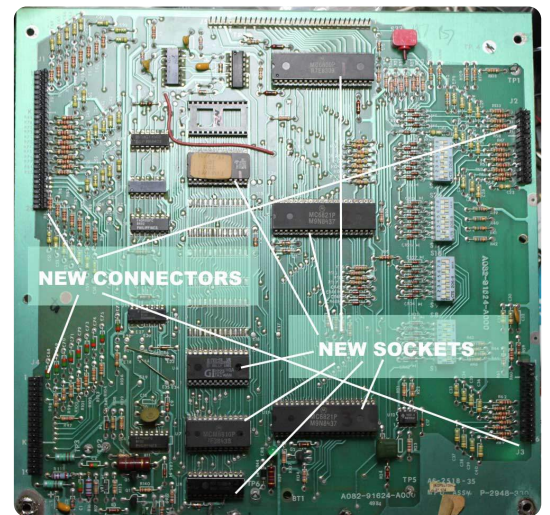
Finally I replaced the battery holder with a remote unit and replaced the female connectors on the wiring harness.

I powered up the game and it ran flawlessly for over an hour.

This MPU is now bulletproofed.
